### **MetroWest Boston Development** Remediation, Construction, Demolition, and Rebuild

Jay L. Hodkinson, P.E., Michael A. Gray, LSP, James V. Errico, P.E., Alfred J. Ricciardelli, P.E., LSP, Randy Meuse, Bruce W. Fairless, P.E., David G. Lamothe, P.E., GZA GeoEnvironmental, Inc.

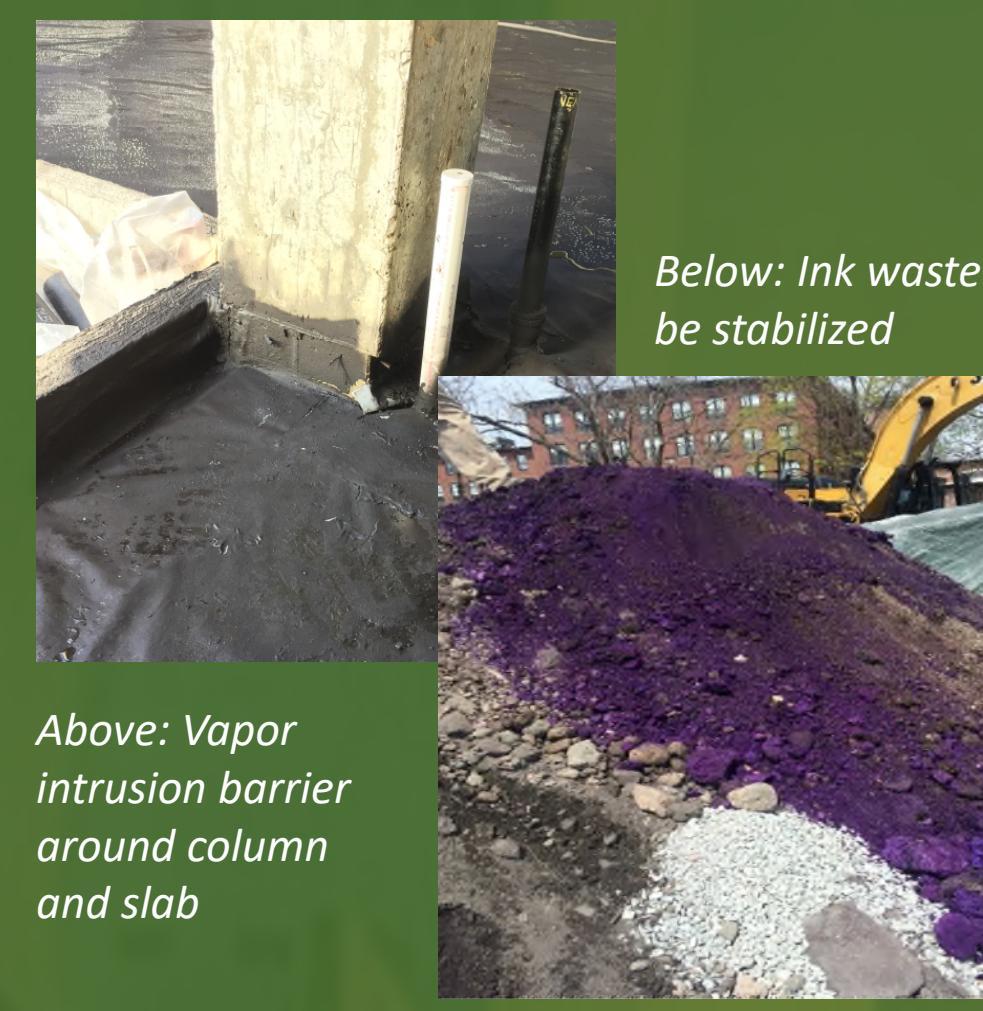
Below: Ink waste to be stabilized ISS §

Separate-phase coal tar and ink waste was remediated by in-situ soil stabilization (ISS).
ISS grout-soil mix was later incorporated into

Above: In-Situ Stabilization of 50' Diameter Tar Well

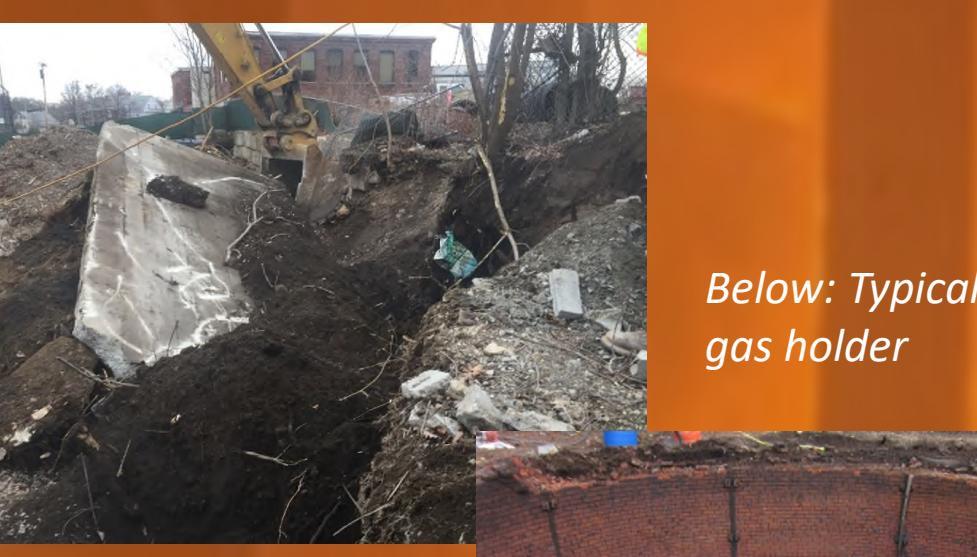
Above: Removal of existing foundations and urban fill

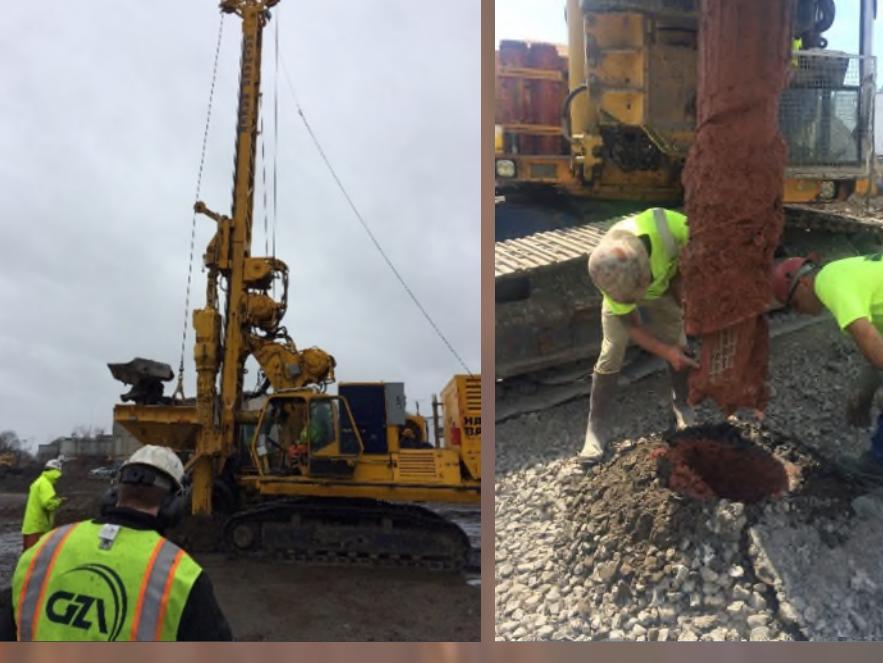
GZA observing the installation of RAPs

Inspection of RIs within gas holder installation

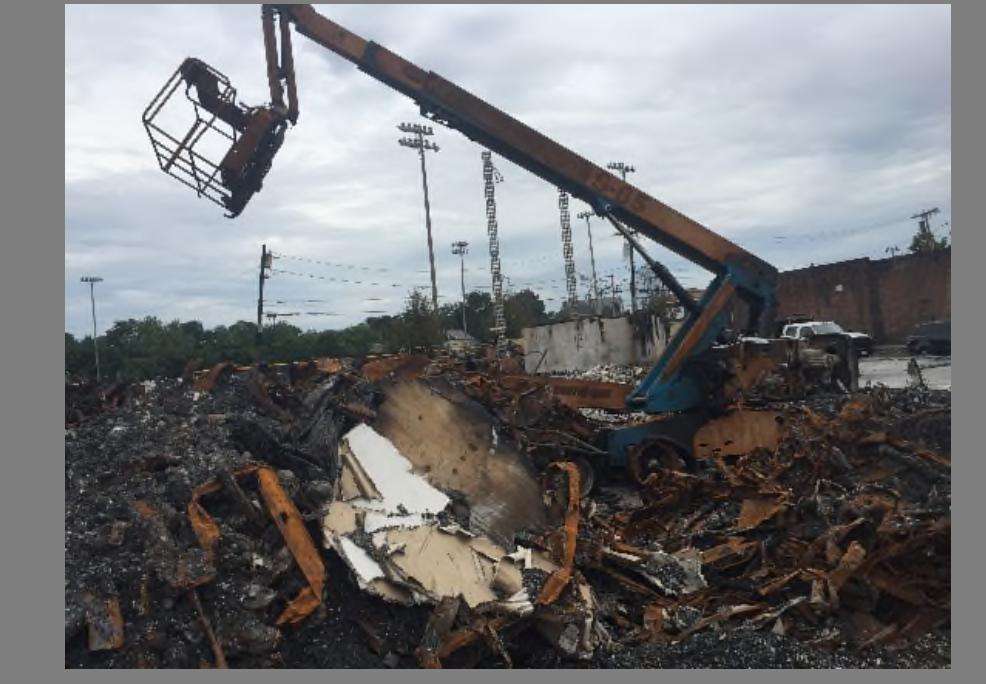
Below: Removing fire

debris for

Fire Assessments were performed by GZA, Callahan, and Alliance to identify the damage to the foundations, assess post-

fire soil contamination, and perform surveys of ash cover affecting nearby abutter's property.
