WEST HOPKINTON HYDROELECTRIC FACILITY PENSTOCK REHABILITATION

The consultant needed to develop a cost-effective design to rehabilitate two penstocks that run partially under NH 127. To meet regulatory standards, the consultant designed a reinforced shotcrete liner to be constructed inside the penstocks from a single access point at the trash rack without disturbing the traveling public. The design tied the new 5-in-thick shotcrete liner to the ca-1906 wood-stave pipe, the 1989 steel pipe, and the surrounding soil to provide structural support. A smooth interior coating decreased friction in the penstock, which avoided a substantial reduction in power production. The design met the client's goals to rehabilitate the penstock and maintain the facility's ability to produce power without disrupting the flow of traffic on NH 127.

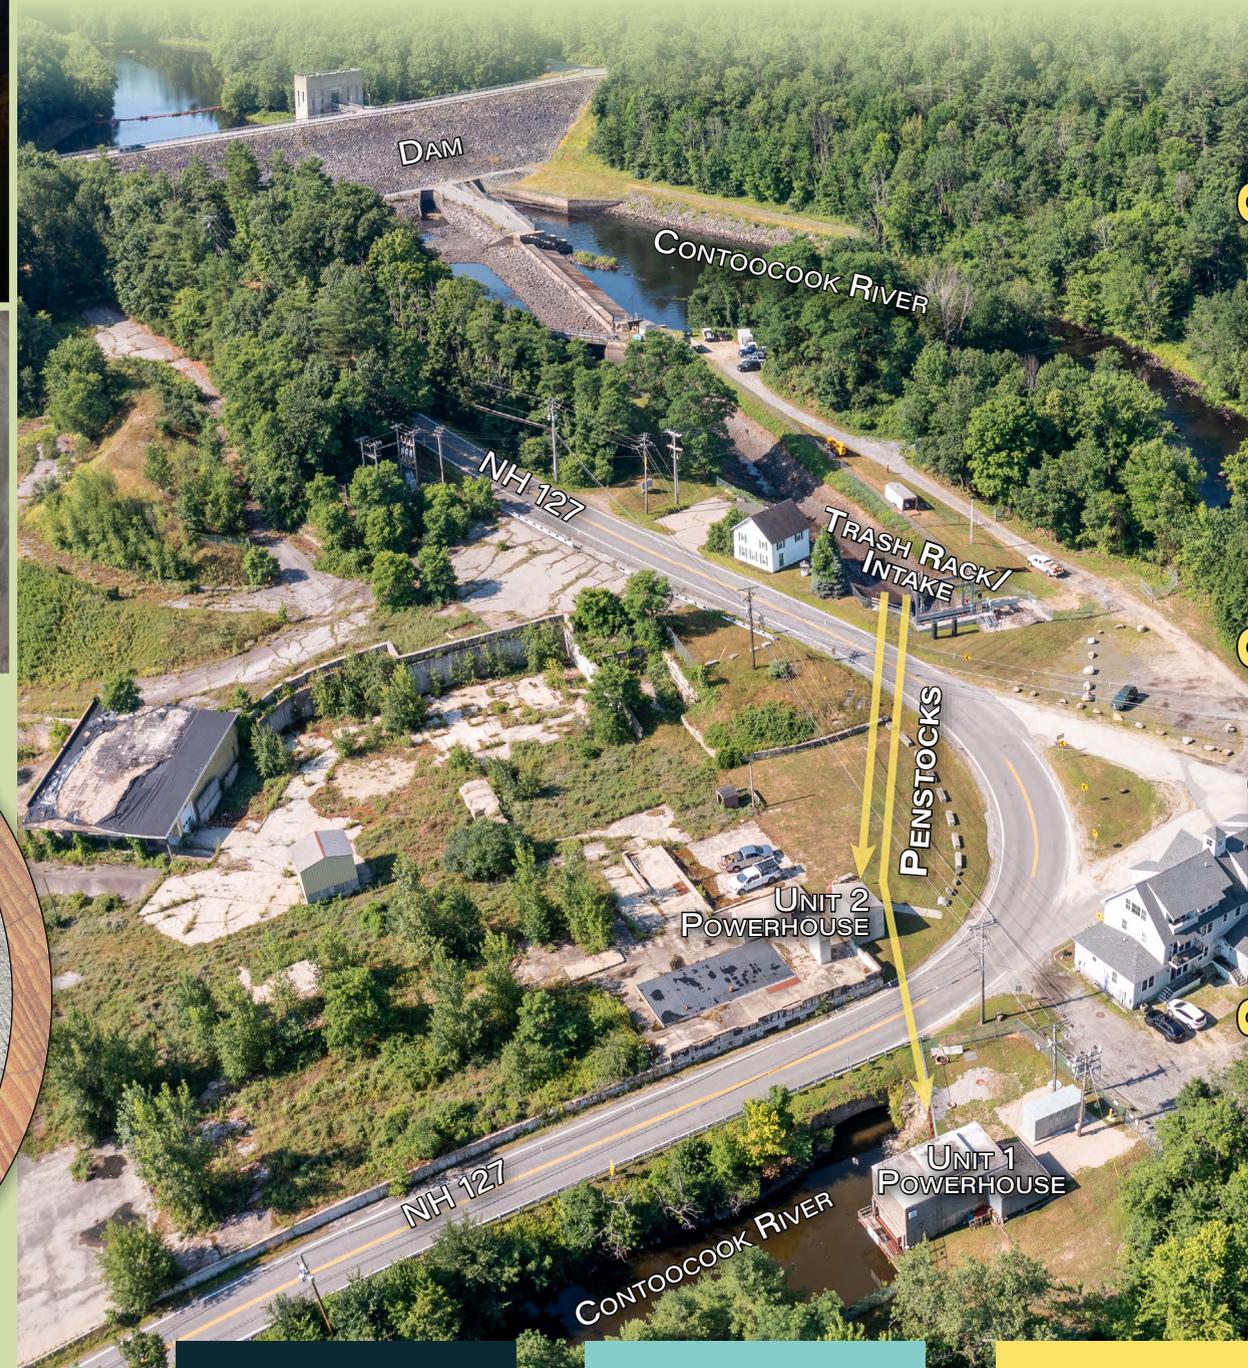
ANNULAR SPACE BETWEEN 1906 WOOD PIPE & 1989 STEEL PIPE
