## NH Route 12 Walpole/Charlestown

### Infiltration BMP Under NH Route 12

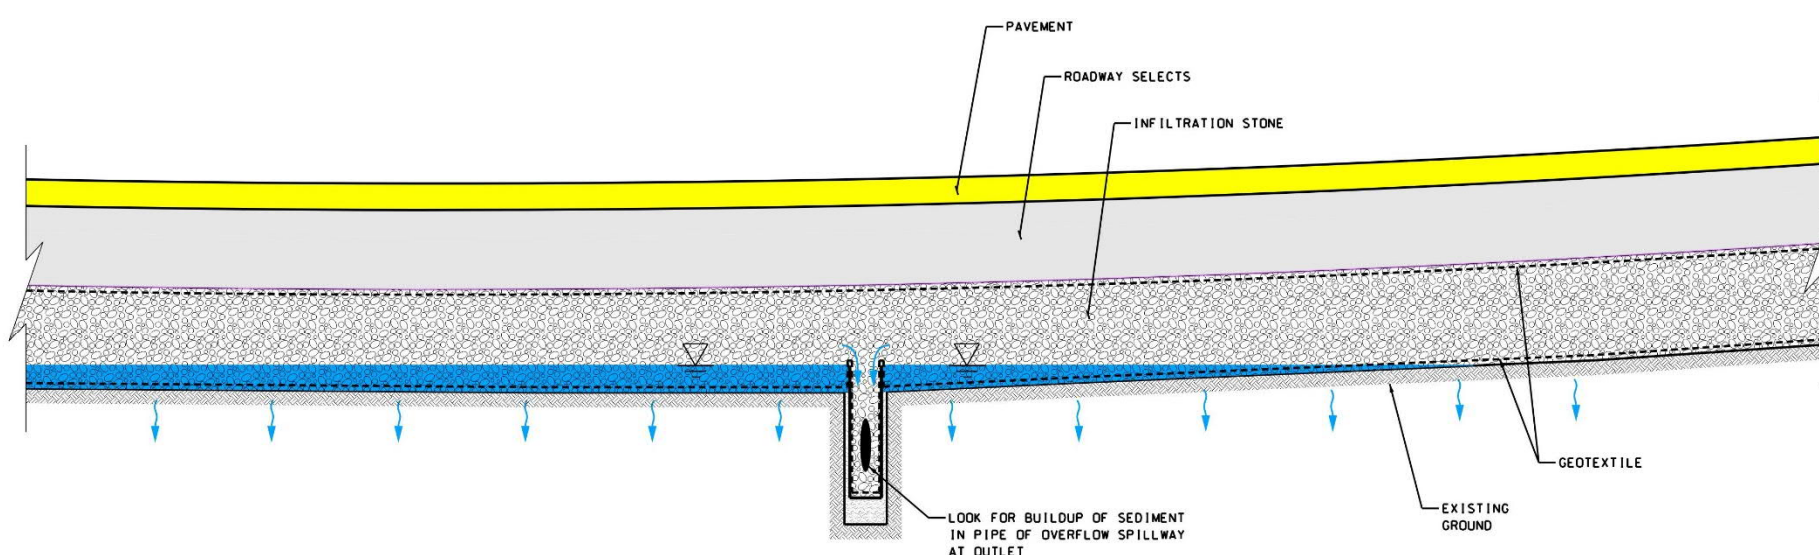
WALPOLE - CHARLESTOWN 14747  
INFILTRATION BMP DIAGRAM  
LONGITUDINAL SECTION

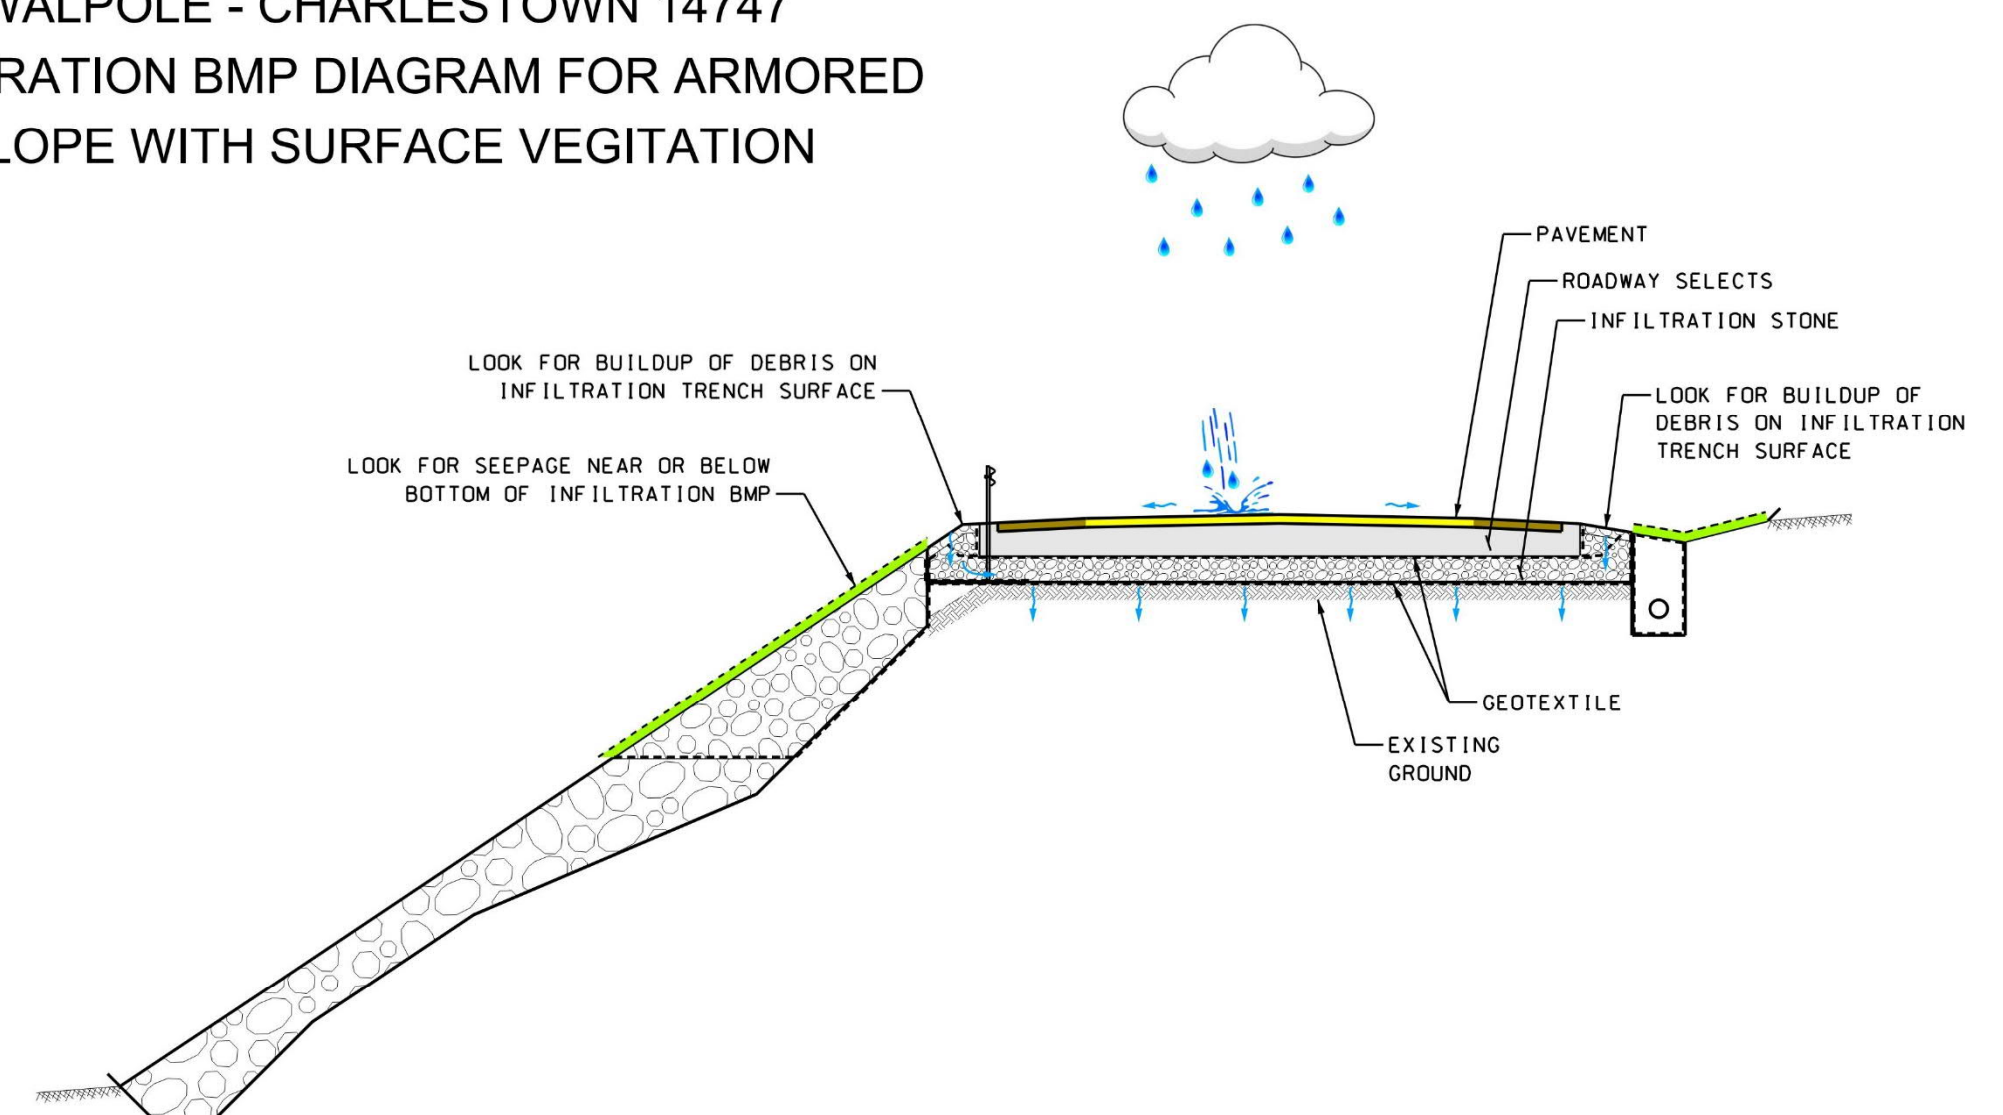
WALPOLE - CHARLESTOWN 14747  
INFILTRATION BMP DIAGRAM FOR ARMORED  
SLOPE WITH SURFACE VEGETATION
