Mattapan Development, Massachusetts

Environmental Remediation, Geotechnical, Design Support, Demolition & Construction Services

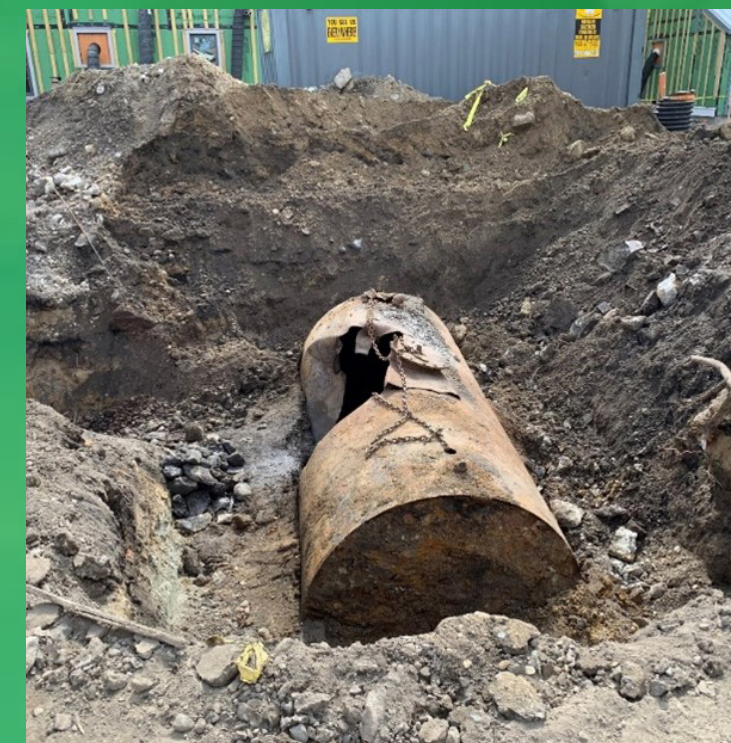
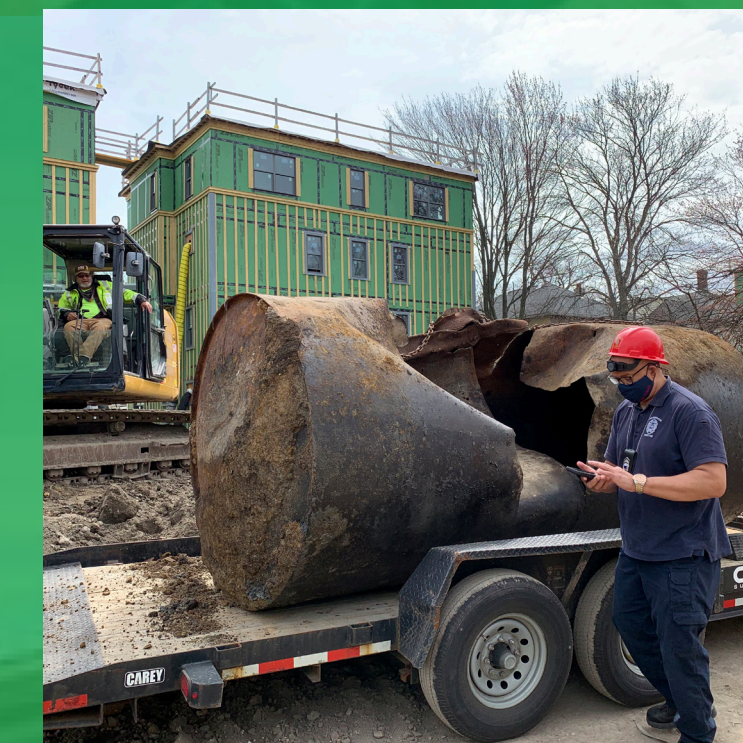
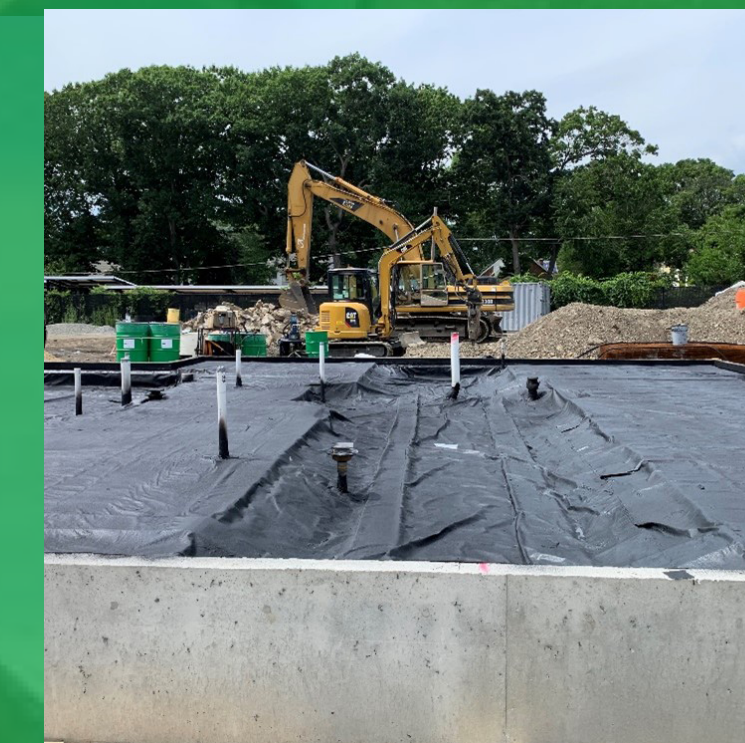
Environmental

- Former automobile services site developed to 4 story affordable housing residential development featuring 76 units
- A Contract to Closure (CTC) was used to remediate the site to allow for residential development.
- Hazardous building materials were remediated by abatement procedures
- Residual petroleum impacted soil was remediated by excavation and offsite disposal during both pre-construction and mid-construction timelines.
- Vapor intrusion barrier system consisted of a membrane and passive ventilation with the ability to go active should indoor air quality require activation.

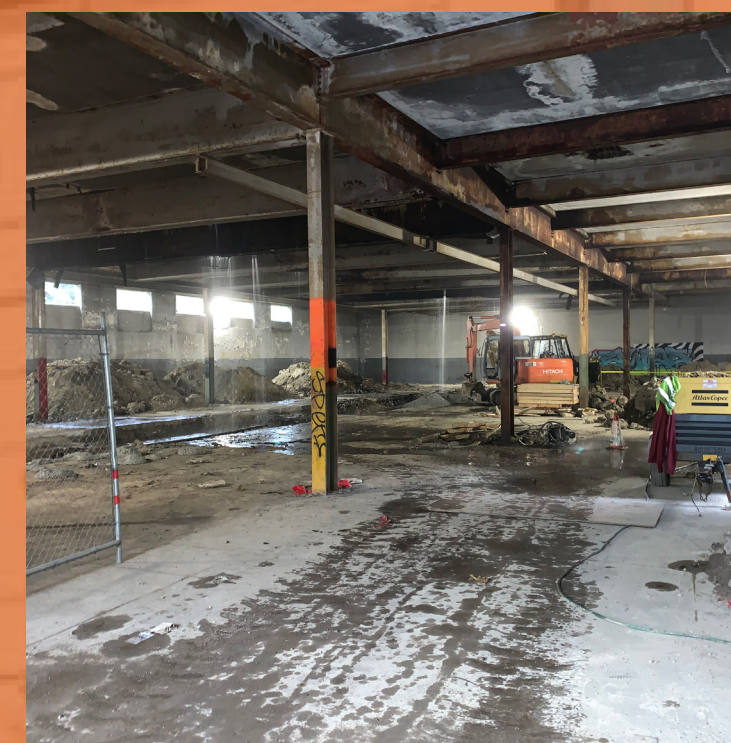
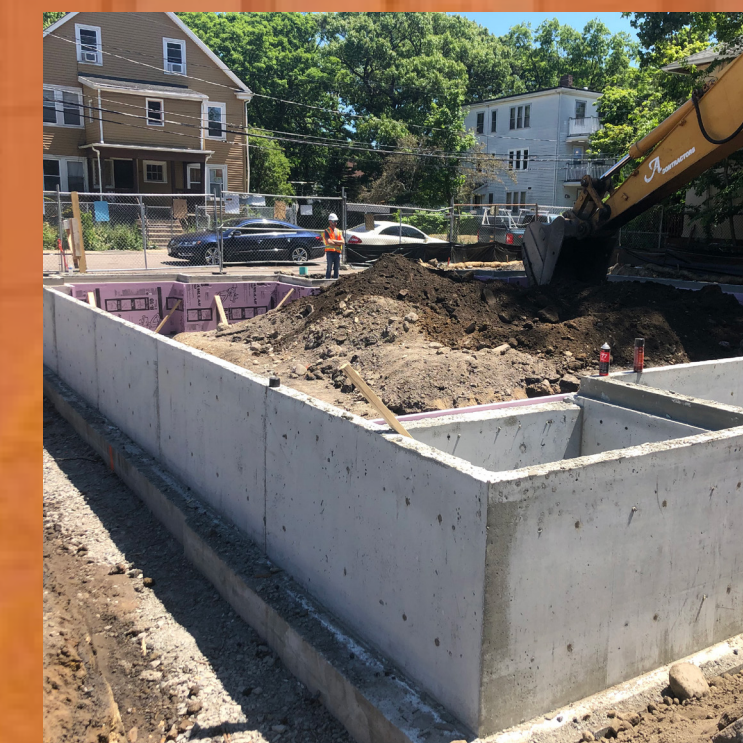
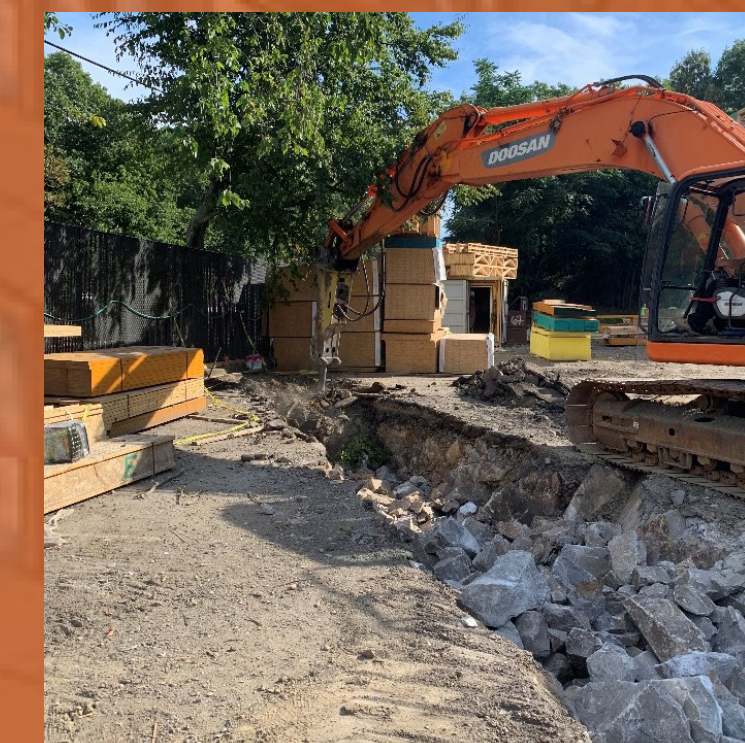
Geotechnical & Site Civil

- On-site fills were of varying composition and densities with presence of ash/cinders
- Storm water recharge systems were relocated and modified given undulating bedrock conditions and multiple areas of residual petroleum contamination subject to Activity and Use Limitations.
- Excavated soil was tracked for proper reuse and disposal
- An existing parking garage beneath one of the buildings demolished prior to construction was retained and integrated into the final design with a mid-rise building built on top of the structure, posing unique geotechnical assessments and recommendations.
- Reuse of urban fills was maximized to reduce off-site disposal.

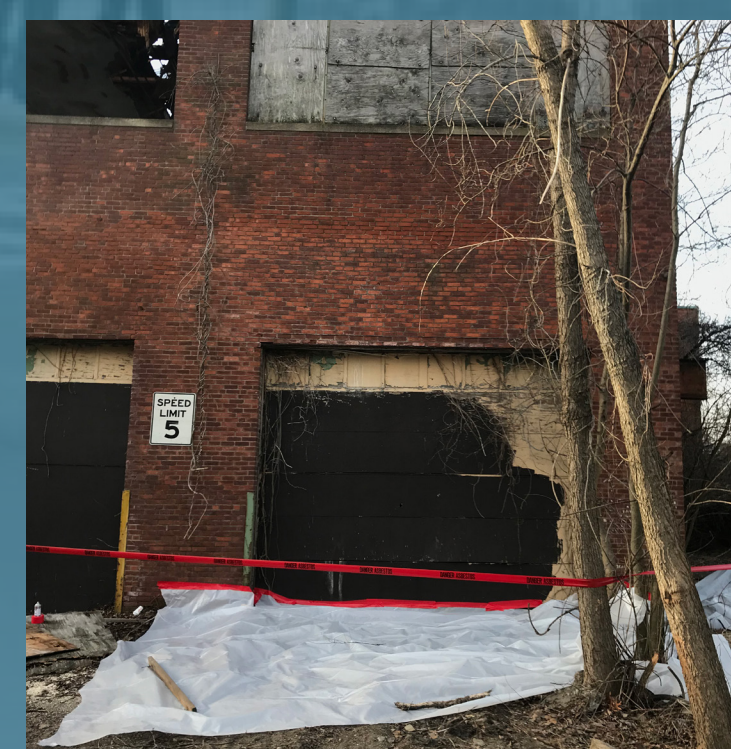
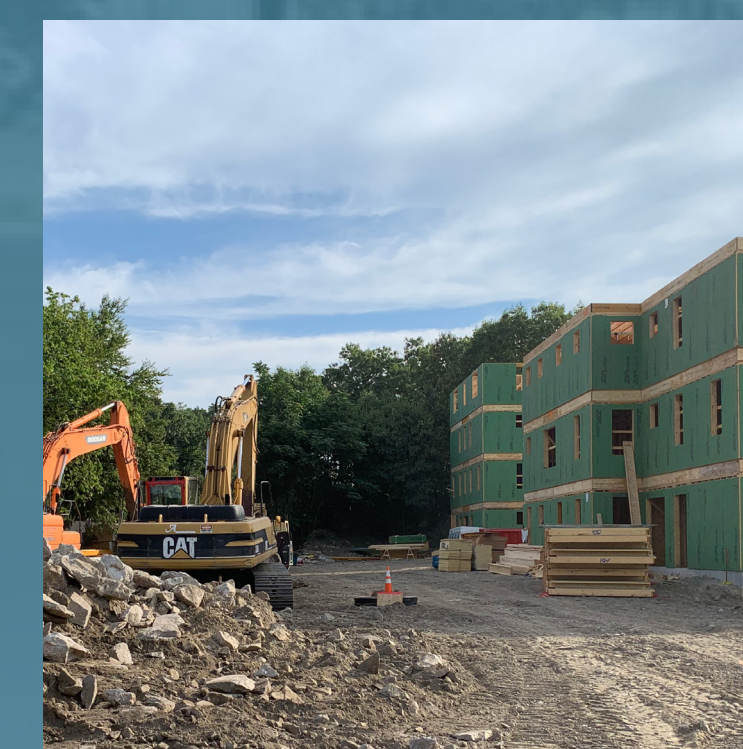
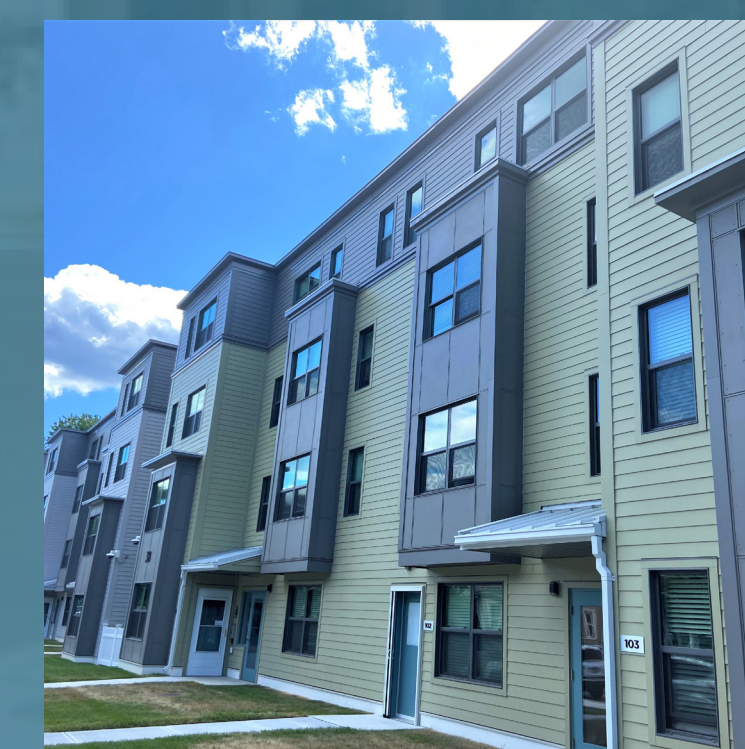
Demolition & Rebuild

- Demolition of two buildings began with abatement of asbestos containing materials and other hazardous materials.
- Preservation of the existing parking garage beneath one of the buildings required precise demolition techniques and structural monitoring.
- Onset of the Covid-19 pandemic during the construction phase posed unique challenges including workforce capacity limitations and unanticipated construction materials costs, directly impacting the projects schedule and budget.
- Conversion of the abandoned and distressed site into an affordable housing development was merely a vision in 2015. The efforts of the project team and specialty contractors revitalized the area, completing construction in 2022.
