# The Marek South

343 MOUNT SUPPORT ROAD  
Lebanon, New Hampshire

In 2020, Saxon Partners began planning to develop an apartment complex on Mount Support Road in Lebanon, New Hampshire. The Upper Valley of New Hampshire has experienced a housing shortage for quite some time and it is estimated that 10,000 housing units are needed by 2030 to meet the region's demand.

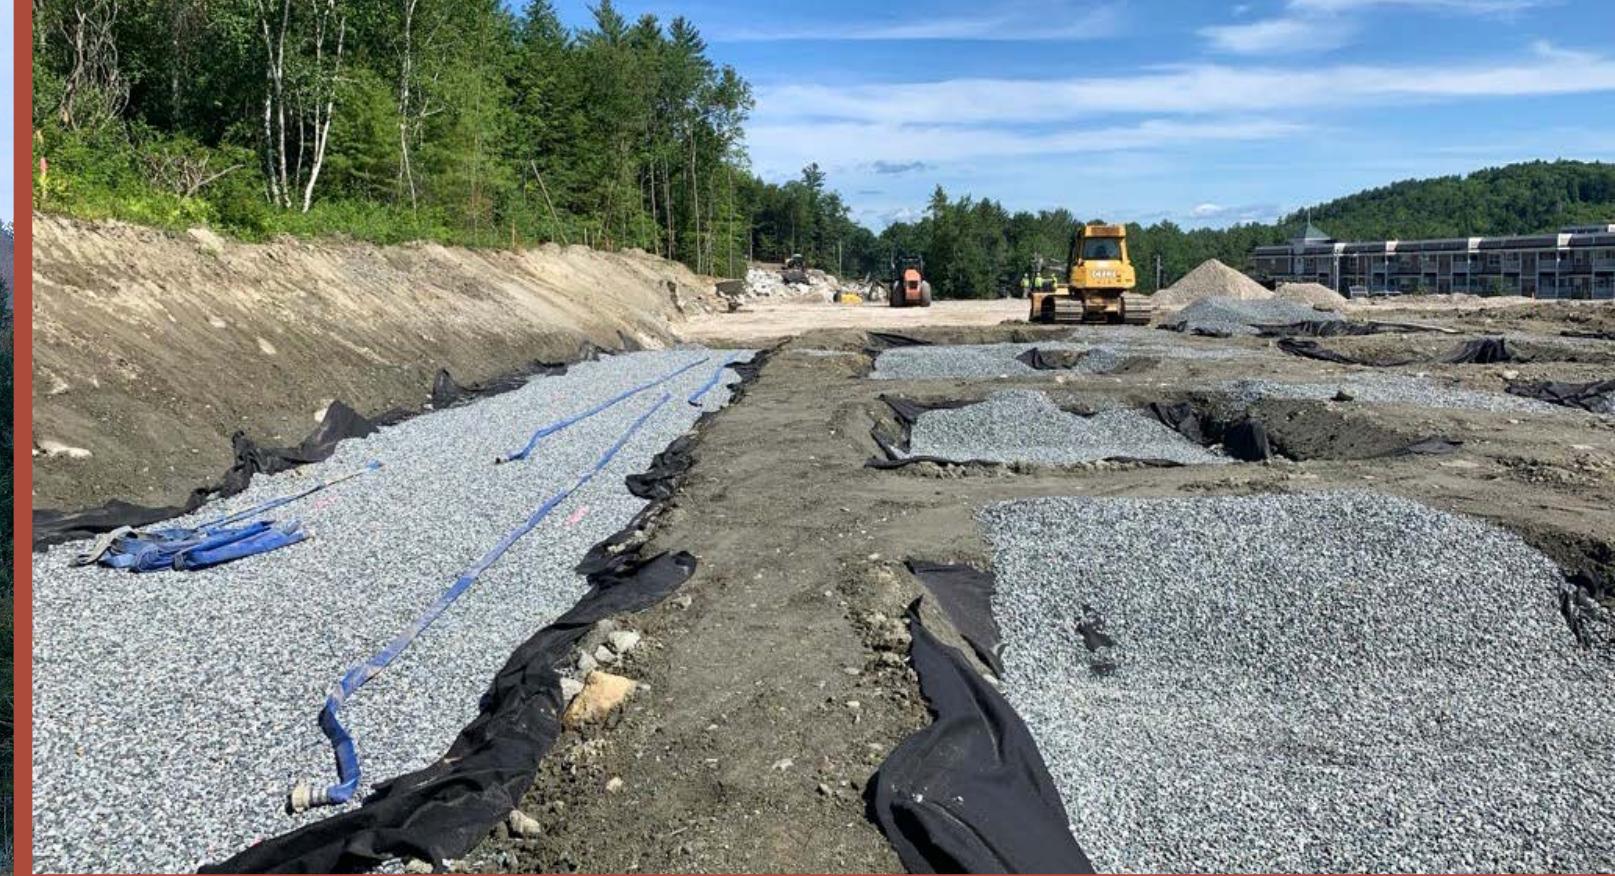
The finish floor of the south building is situated 15 feet below the groundwater table, and the geotechnical report addressed recommendations to control the groundwater using crushed stone below the perimeter footings and floor slab and a gravity drainage underdrain system around the perimeter of the building and below the floor slab.

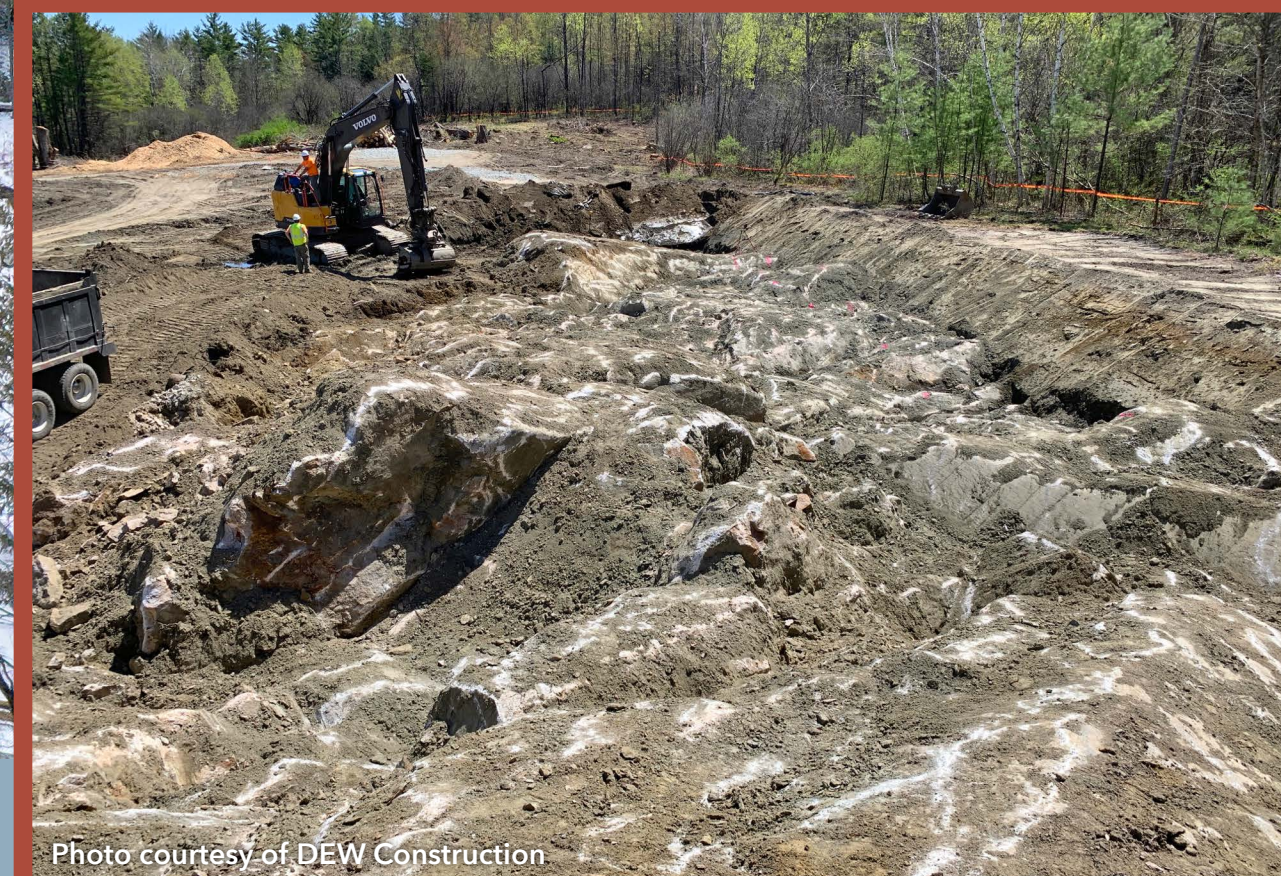
Bedrock removal by blasting was required for the amenity building and a portion of the north building. The configuration of the bedrock and subsequent blasting operations resulted in blasting to depths below the proposed foundation depths and created loose, overblasted bedrock that required removal to an in-tact bedrock surface for building support. S.W.COLE provided construction observations and consultation to assist in determining the loose rock was adequately removed.
